Study on Behavior of Ductile Iron Pipelines with Earthquake Resistant Joint Buried across a Fault

Shogo Kaneko (Ductile Iron Pipe R & D Dept, Kubota Corporation, Japan) · Masakatsu Miyajima (School of Environmental Design, Kanazawa University, Japan) · M. H. Erami (Graduate School of Natural Science and Technology, Kanazawa University, Japan)

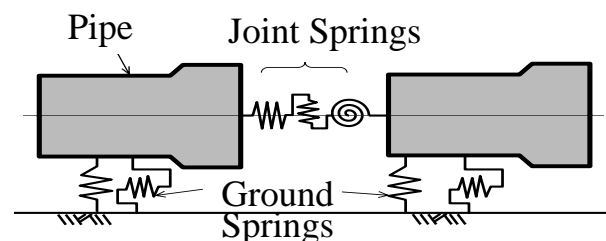
Fig. 1 Outline of analysis model

In displacement analysis for buried pipelines, a behavior analysis method is generally used in which pipes are expressed as beams laid on an elastic floor, and their joints and the interactions with the ground as springs (Fig.1). In the conventional method, the directions of springs that link pipe and ground are fixed. So, when the ground displacement in the fault reaches several meters, drastic errors in analysis may result. Therefore, in this study, we employed large-displacement analysis method which the directions of the springs can change depending on the movements of pipe and ground. The method used in this study is shown in Fig.2.

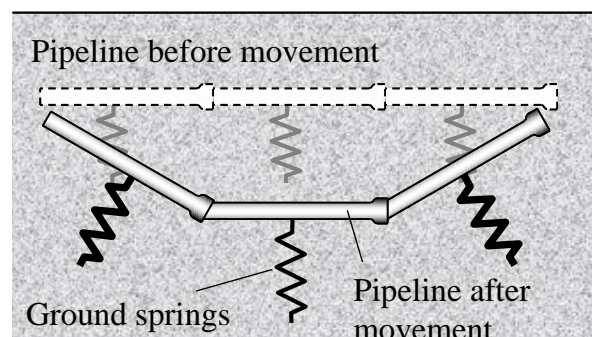
Fig. 2 Large-displacement analysis method

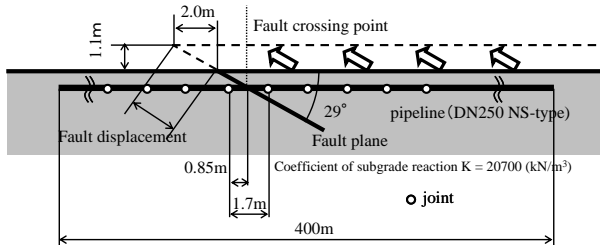
Fault type	Reverse fault
Amount of fault displacement	2.3m
Pipeline	DN250 NS-type ductile iron pipe
Pipeline length	400m
Burial depth	0.6m
Ground condition	Coefficient of subgrade reaction $K=20700(\text{kN}/\text{m}^3)$

Fig. 3 Analysis model and conditions

The analysis model is shown in Fig.3. A reverse fault model, in which horizontal displacement was 2.0 m, vertical displacement was 1.1m and inclination was 29 degrees, was set up with reference to the result of a survey by Kataoka et al. of the Nojima fault, which underwent in the Kobe Earthquake.

In this study, the length of each pipe was set at 1.7 meters, a value smaller than the regular pipe length 5m, so that the behavior of multiple pipes in this displacement range could be analyzed.

The pipeline was modeled as an assembly of beams connected with joint springs and ground springs. Considering the properties of the elements in this model, these springs were assumed to be non-linear springs.

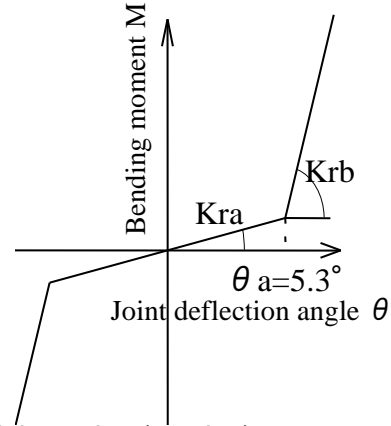
Fig. 4 Joint spring (rotation)

The properties of the joint springs were determined based on results of experimental studies. For instance, the rotation spring of joint becomes resistant to further deflection when its deflection angle reaches 5.3 degrees, the limit value of deflection (Fig.4).

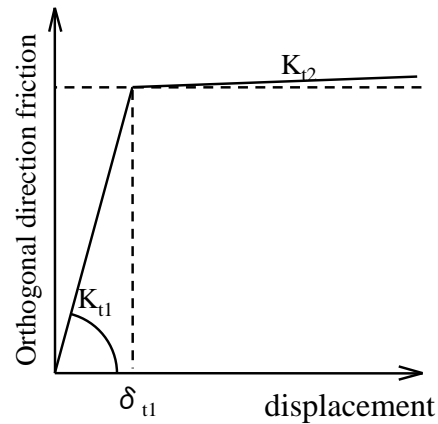
Fig. 5 Ground spring (orthogonal direction)

The ground spring property was based on friction between pipe and ground and the reactive force from the ground. For instance, the relationship between friction in a direction orthogonal to the axis and displacement in that direction were set up as bilinear relationships (Fig.5).

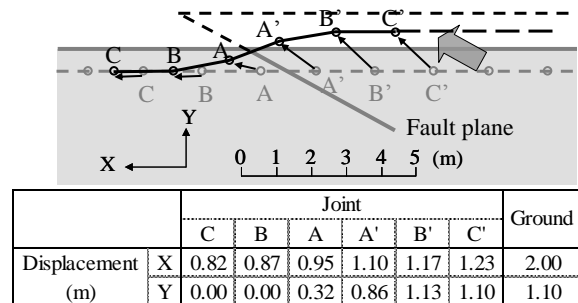
Fig. 6 Analysis result of pipeline behavior

Results for analysis of pipeline behavior near the fault are shown in Fig.6. The pipeline could follow fault displacement because of deflections in the joints A, B, A' and B'. The displacement in the Y-direction at joints B' and C' was almost the same as the 1.1 m displacement of the ground, indicating that they moved together with the ground.

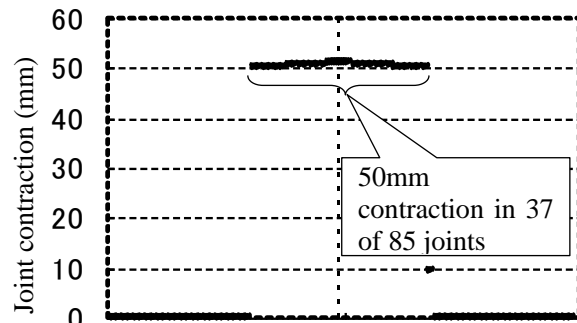
Fig. 7 Joint contraction

Shown in Fig.7 is the analysis result for the contractions/expansions of the joints. Since the ground was displaced in such a way that the pipe had to contract in its axial direction, only contracting movements took place in the joints. In 37 joints centering on the fault, contraction was approximately 50 mm, the limit contraction value for each. The total contraction for the pipeline was 1.96 m, a value almost equal to the 2.0 m displacement of the ground in the axial direction, showing that the ground displacement was almost entirely absorbed by the joint contractions. The contractions of individual joints relative to the fault displacements (in the axial direction) are shown in Fig.8. Also shown is the movement of the pipe: when the fault displacement was still small, joint A, closest to the fault, contracted first. When the contraction in joint A reached its limit value, joint B began to contract; then, joint C, joint D and so on, one after another, following the movement of the joints closer to the fault.

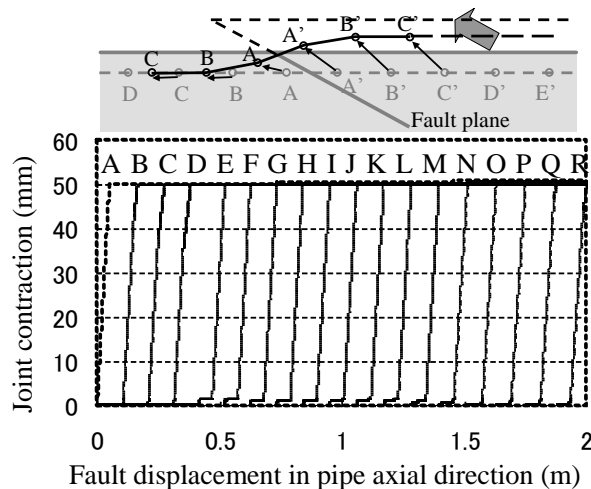
Fig. 8 Joint contraction

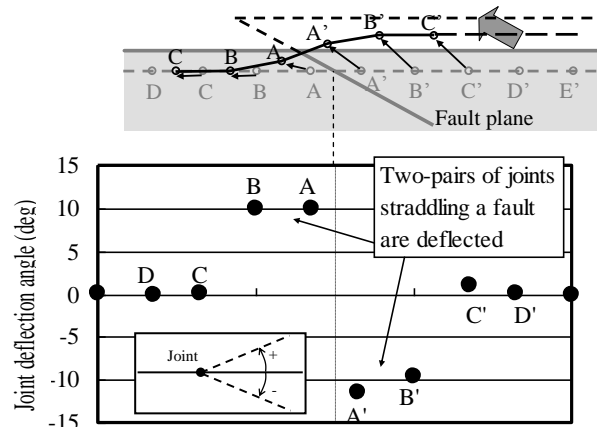
Fig. 9 Joint deflection angle

The results of joint deflection angle analysis are shown in Fig.9. Plus or minus sign in front of deflection angles on the Y-axis indicates the direction of deflection. This graph shows that deflections were generated in 4 joints straddling the fault. Shown in Fig.10 are the deflections angles in Joints A, B and C relative to fault displacement orthogonal to the pipeline axis. Deflection was also first generated in joint A, the closest joint to the fault, when the fault began to move. When this deflection reached its limit value, joint B began to be deflected.

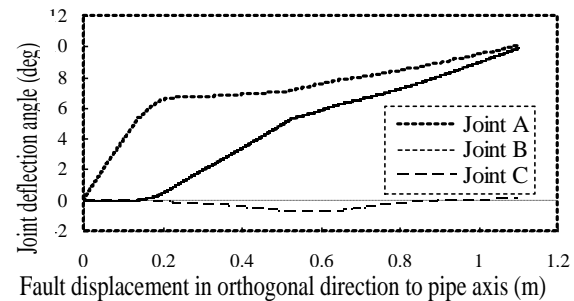
Fig. 10 Joint deflection angle relative to fault displacement

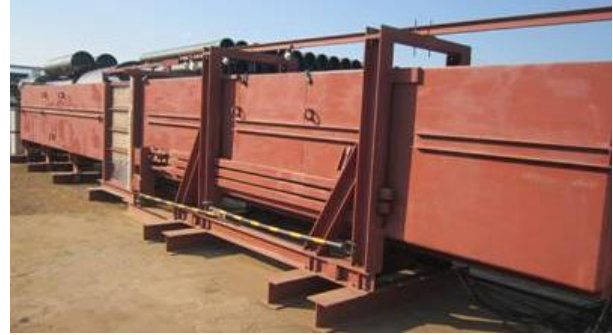
Photo 1 Setup of the experiment

The setup of the experiment is shown in photo.1. Photo.2 shows the fault crossing part from the side and indicate fault.

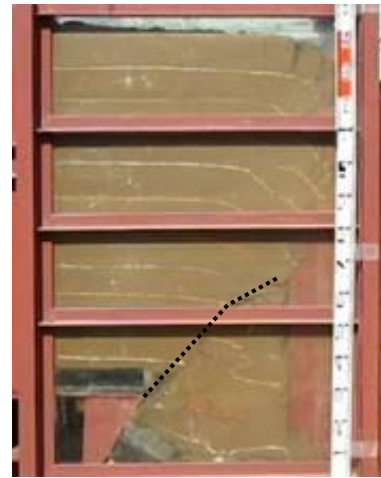
Photo 2 Fault part side

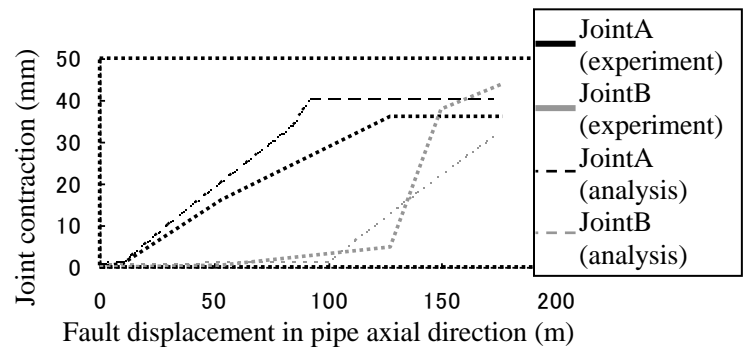
Fig. 12 Joint contractions

The experiment results of contractions of joint A and B relative to the fault displacements (in the axial direction) are shown in Fig.12. The analysis results are shown in this graph in addition, too. The pipelines moved following by the ground displacement, and it was confirmed that the experiment results were almost the same as the analysis results.

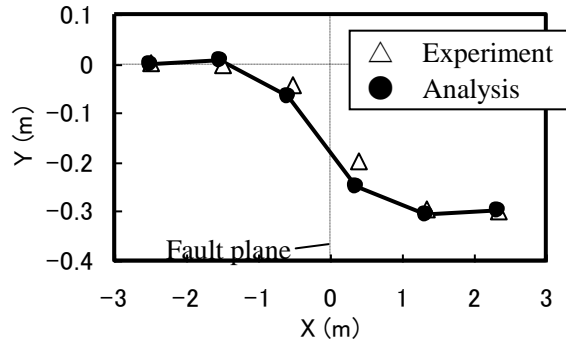
Fig. 13 Pipeline behavior

We show the result of a measurement of pipeline behavior in fig.13. Like the analysis results, it was revealed that the pipeline followed fault displacement in the experiment results, too. However, in the joint A and A', the closest joints to the fault, it turns out that the pipeline displacement magnitude in an experiment is smaller than analysis.

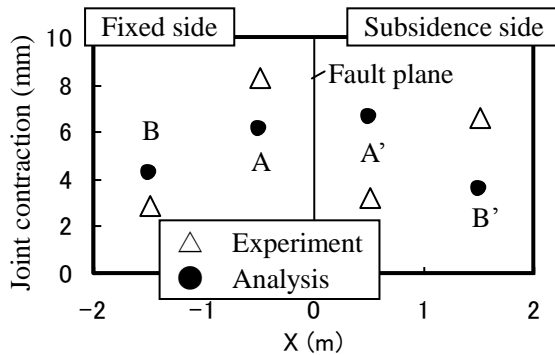
Fig. 14 Joint deflection angle

Therefore I analyzed joint behavior in detail. The joint deflection angle of joint A, A', B and B' is shown in fig.14. With the container of the subsidence side, deflection angle of joint B' neighboring joint A'

which was the closest to the fault was bigger. And we confirmed a tendency unlike the analysis result. In other words, it is estimated that the pipeline behavior of the fixed side is different from the subsidence side.

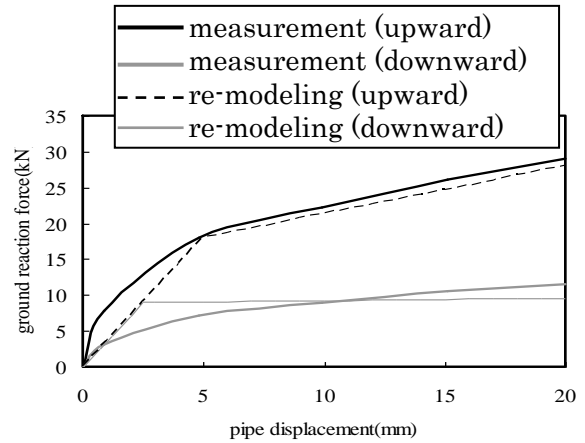
Fig. 17 Measurement result of ground reaction force

The result is shown in Fig. 17. It turned out that the ground reaction force when the pipe moved downward was bigger than when it moved upward.

From this experimental result, as shown in Fig. 17, we modeled ground spring and analyzed again.

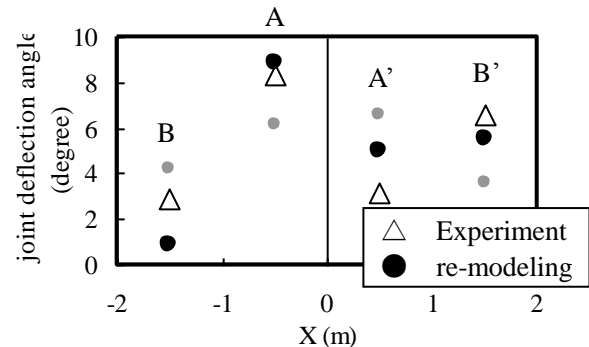
Fig. 18 Joint deflection angle

Joint deflection angle is shown in Fig.18. The analysis result which re-modeled the ground spring was approaching by the experimental result.

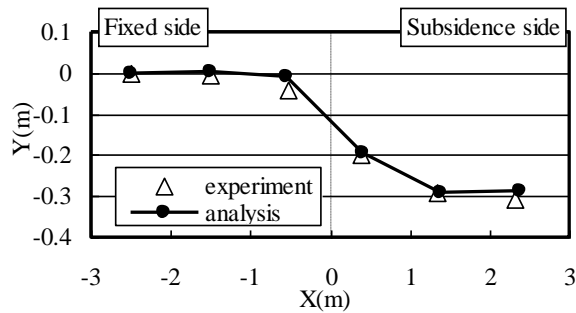
Fig. 19 Pipeline behavior

We show the result of a measurement of pipeline behavior in fig.19 and the result of a measurement of deflection of joint A, B and C in fig.20.

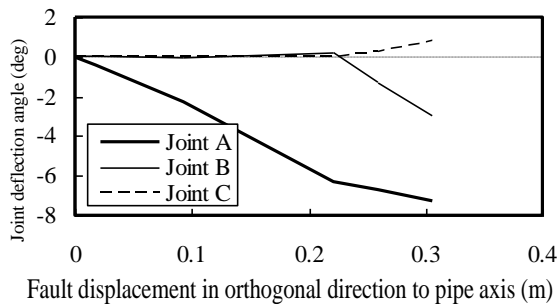
Fig. 20 Joint deflection angle relative to fault displacement
